# TANDBERG PRODUCT BULLETIN

PREPARED BY: Prod. Lab/. T.B. B.S. DATE OF ISSUE: 11.1.78..... No.: TB 71E...

<p>MODEL:.....TCD 330/..... TCD 310 MK 11</p> <p><b>THE CHANGE IMPLIES:</b></p> <p>Delivered equipment <input type="checkbox"/></p> <p>Future deliveries <input type="checkbox"/></p> <p>Spare parts stock <input type="checkbox"/></p> <p>Spare part compability <input type="checkbox"/></p> <p>Manual <input type="checkbox"/></p> <p>Other.....</p>	<p>REASON FOR CHANGE:..Tape path problems.....</p> <p>Design improvement <input type="checkbox"/></p> <p>Custom modification <input type="checkbox"/></p> <p>Supply difficulties <input type="checkbox"/></p> <p>Production adaption <input type="checkbox"/></p> <p>Standardization <input type="checkbox"/></p> <p>Correction of drawing <input type="checkbox"/></p> <p>Other.....</p>
---	---

TAPE PATH PROBLEMS ON MOD. TCD 330 and TCD 310MK11.

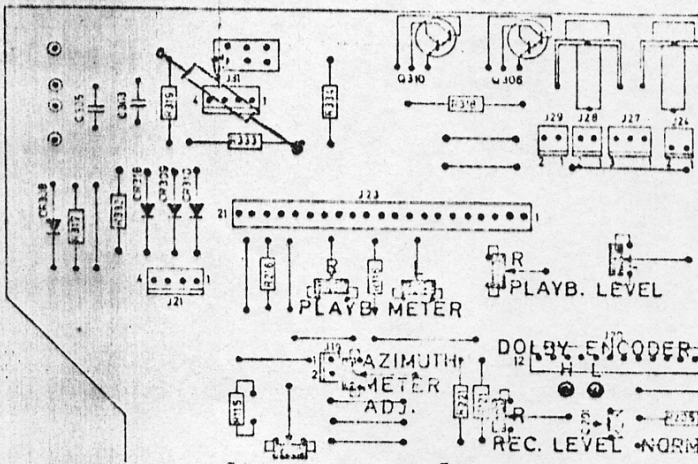
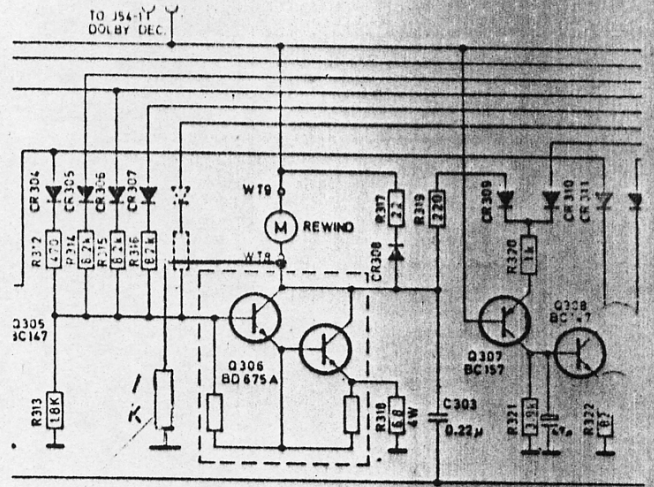
Fig.

Modification: Introduction of back-tention on supply motor:  
 Resistor 1 kOhms, 1/2 W is connected as shown in fig.

*1 kohm 1/2 w*

Part of A 1.

All modifications including those described in P.B. No. 71 are carried out from Ser. no. 4181142. All machines in stock are also modified from shipping date Feb. 1. -78. The modified machines are marked with T on the identification label on carboard box.
