Product: TCD 3004

Service Information

Click-noise at operation.

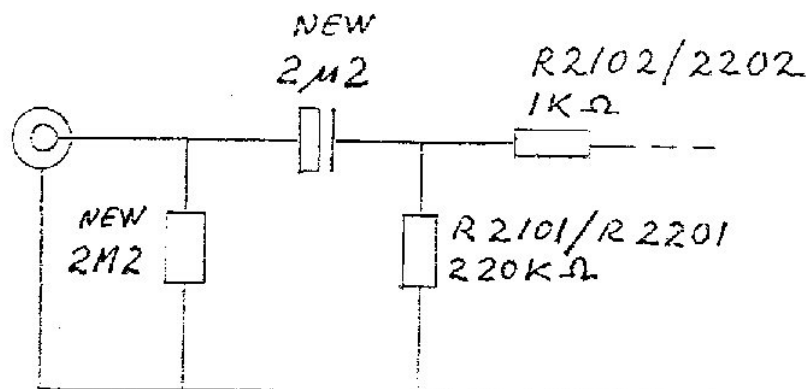
When connected to some types of preamps or receivers, click-noise may occur when some buttons on the preamp/receiver are operated.

This problem is solved by connecting a 2,2 micro farad electrolytic capacitor and a 2,2 megaohm resistor to the "record" cinch sockets as shown in the diagram:

This solution will be introduced on the production line in January 1982.

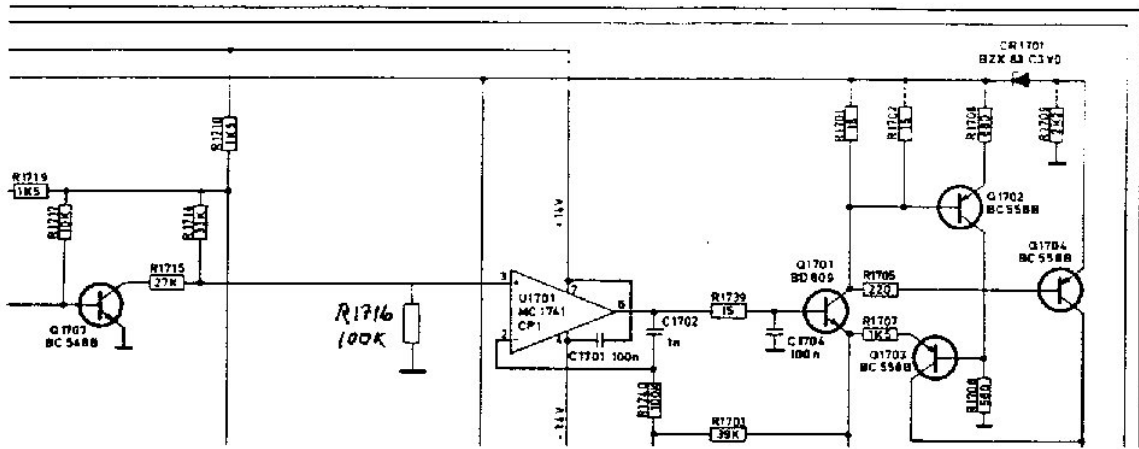
Part of assembly no. 9

From serial No. 16600 -	Symptom	Modification
200	Low frequency noise	A4 board: R732/R832, change to 680 kohm R733/R833, change to 1 kohm
350	Head bridge moves from release when power off.	A10 board: See processor diagram page 27. in the Service Manual. Additional circuit from serial No. 350
810	Intermittent Tape Counter 1)	A7 board: Replace the board with the new type.
893		New Dolby NR * circuits LM1111. The boards A1, A3 and A4 are replaced from the factory.
922	Reduce heat in the erase head 1)	A7 board: R1516 change to 560 ohm R1509/R1510 change to 120 ohm R1508/R1511 change to 4,7 kohm Oscillator voltage: Approx. 7V Oscillator frequency: 80-84 kHz.
	Reduce take-up tension 1)	A9 board: R1715 change to 47 kohm 2) R1716 change to 100 kohm Take-up tension: Approx. 60 gr/cm
1125	Distortion 2nd harmonic 1) Only from serial No. 893 to 1125	A1 board: C123/223 change to 47uF electrolytic A3 board: C518/C618 change to 47uF electrolytic

1) We recommend those changes to be done on all units at service.

2) See separate diagram
