Information No: 840330

Product: TPT 3001

Service Information

#### Unstable decoder circuit

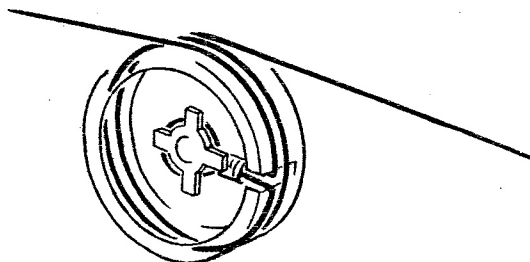
New dial pointer drive cord  
-----

To avoid problems related to the fixing of the dial pointer drive cord, reported from various markets, the following change must be made:

1. Change the cord mounting drawing in the service manual paragraph 1.2 according to new drawing. (Below)
2. Remove old dial pointer drive cord.
3. Mount the new cord according to drawing.
4. Mount the dial pointer according to paragraph 1.2 of the service manual.
5. Position the pointer and realign tuner dial according to service manual page 9, figure 11.
6. The new cord may be ordered from Tandberg A/S' Service Department on Part No. 997004

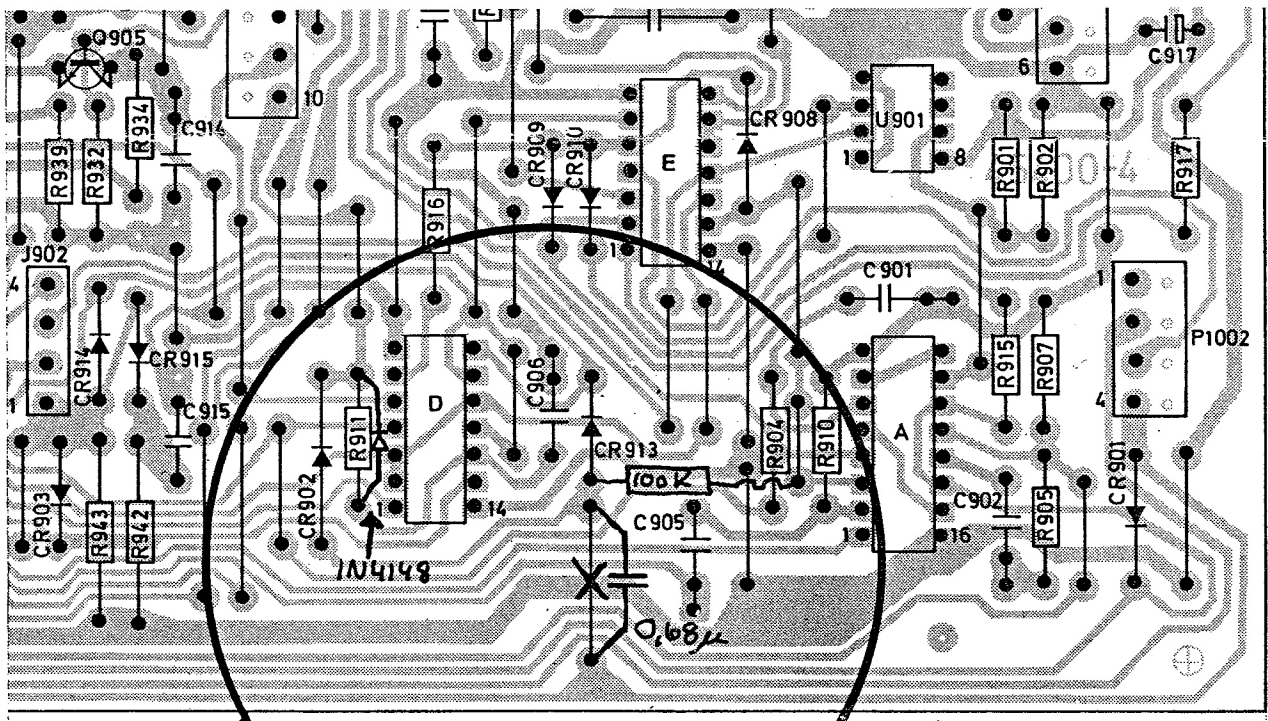
Part of tuning system 1, PC board seen from the solder side.

Symtom: Programme loss, continuous search.

Cause : Replace strap facing anode of CR 913 with a condenser  
0,68  $\mu$ F 100V foil part No. 282064 (15 mm between  
component legs).

Insert a 1/3W 100 kohms resistor between the anodes of  
CR 908 and CR 913, part No. 280944.

Insert diode 1N4148 parallel to R 911, the anode side  
facing pin 12 of U 905, part No. 247007.

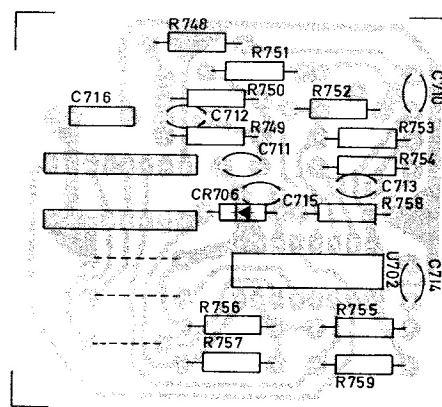
Touch sense board, component side

These modifications give increased sensitivity for switching from pre-set to manual tuning and are less sensitive for temperature variations.

In addition to the previous modification we will also recommend that you do the following modification on the tuning sense board as shown in the figure. This modification makes the receiver less sensitive for external radiation fields.

- CR706 is turned in opposite direction
- R756 and R758 are connected as shown in the figure
- R754 is replaced with 2 pcs. of 330 kohms and a wire is soldered to the center of the two 330 kohms. The other end of the wire is connected to the flat spring behind the flywheel on the tuning knob.

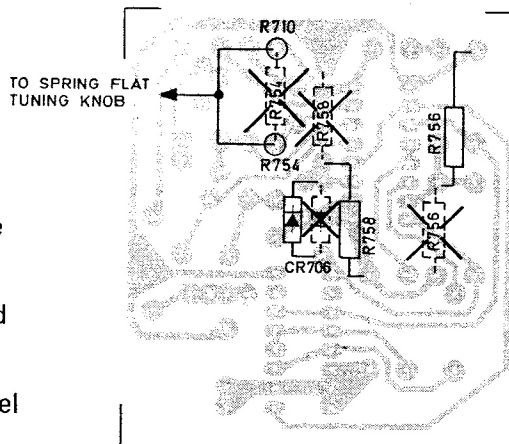
Touch sense board, component side

2. This modification also makes the receiver less sensitive for external radiation fields.

On receivers with serial No. from 01077 to 01691 the following modifications should be carried out:

- CR706 is turned in opposite direction
- R749, change the value to 47 kohm
- R750, change the value to 1 Mohm
- R751, change the value to 1 Mohm
- R752, change the value to 820 kohm
- R753, change the value to 680 kohm
- R755, change the value to 330 kohm
- R754 is replaced with 2 pcs. of 330 kohms and a wire is soldered to the center of the two 330 kohms. The other end of the wire is connected to the flat spring behind the flywheel on the tuning knob and the foil is cut as shown in the figure.
